Site Effects and Damage Patterns

A set of observations on site effects and damage patterns from the M_w 8.8 Maule, Chile, earthquake is presented, focusing on identification of structural damage variability associated with nonuniform soil conditions and subsurface geology. Observations are reported from: (1) the City of Santiago de Chile (Américo Vespucio Norte Ring Highway, Ciudad Empresarial business park), (2) the Municipality of Viña del Mar, and (3) the City of Concepción, extending over 600 km along the Chilean coast. Reconnaissance information and ground motion recordings from the megathrust event are combined with site investigation data in the regions of interest. Comparisons against macroseismic observations related to uneven damage distribution from the M_w 8.0 1985 Valparaíso earthquake are discussed. Complexities associated with identifying the mechanics and underlying physical processes responsible for the manifestation of these effects are elucidated. [DOI: 10.1193/1.4000029]

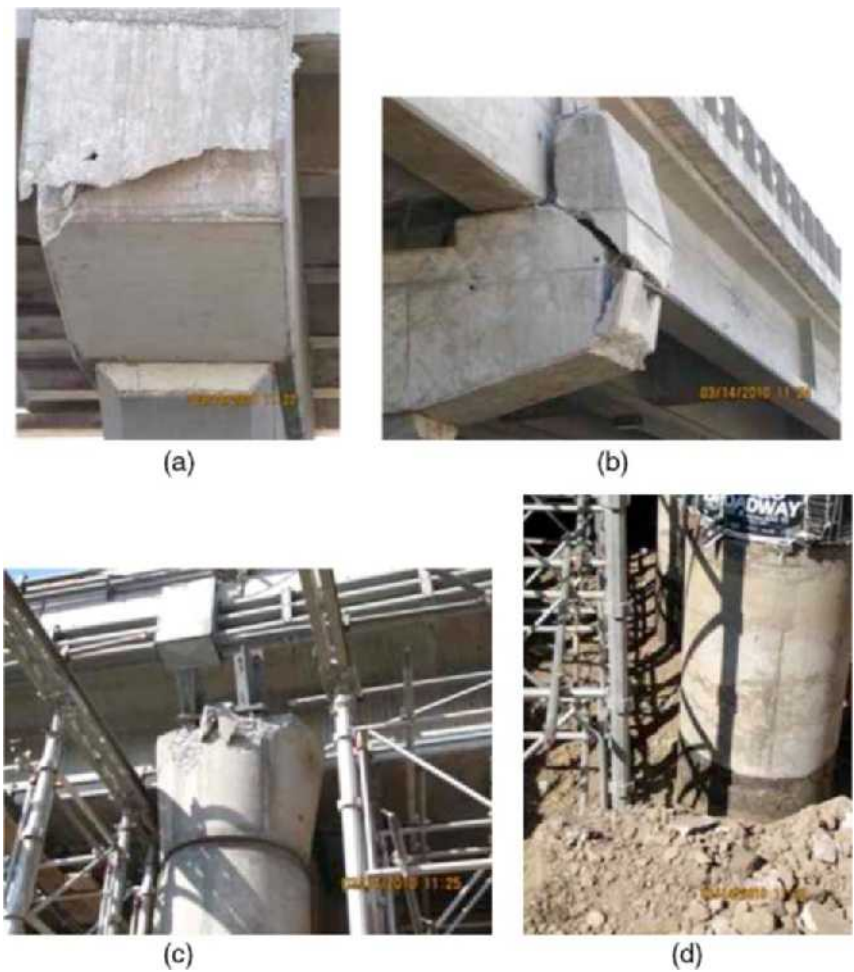
More specifically, the bridge of the Paso San Martín overpass (33.3660°S, 70.6891°W) suffered repairable structural damage, characterized by shear key failures as shown in Figures 5a and 5b. Longitudinal and transverse deck movement was also documented, leading to joint damage between the deck segments (Figure 5c). Two pile-diameter-deep excavations conducted as part of the post-earthquake investigation (Figure 5d), revealed no visible

Figure 5. Paso San Martin (33.3660°S, 70.6891°W, 1122 hrs on 03/14/2010). Shear key failure and longitudinal, transverse deck displacement.

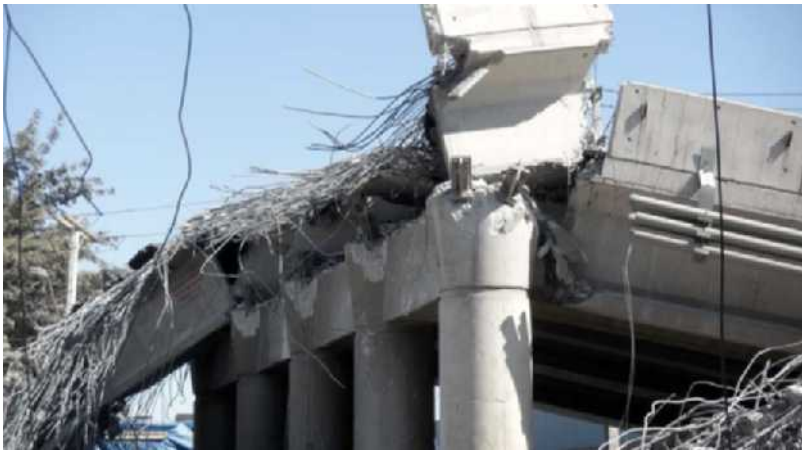
Figure 6. Paso Superior Lo Echevers (33.3759°S, 70.7476°W). Collapse of the eastbound deck of the Américo Vespucio Norte ring road (Dr. Roberto Leon, personal communication).

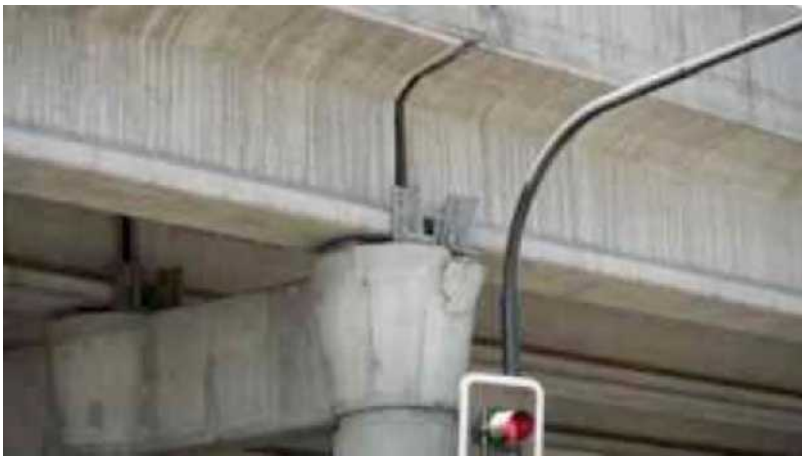
Figure 7. Paso Lo Boza (33.3865°S, 70.7601°W). Minor structural damage of shear keys (Source: Dr. Roberto Leon, personal communication).

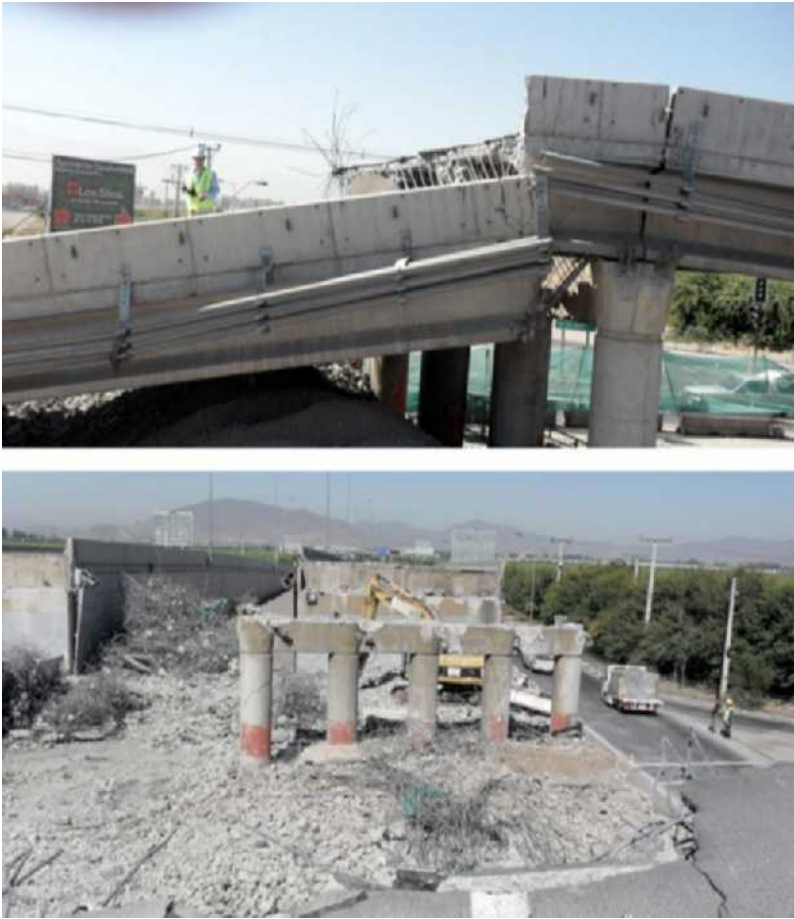
Figure 8. Paso Miraflores (33.3945°S, 70.7700°W). Deck collapse detail (Source: Dr. Roberto Leon, personal communication).

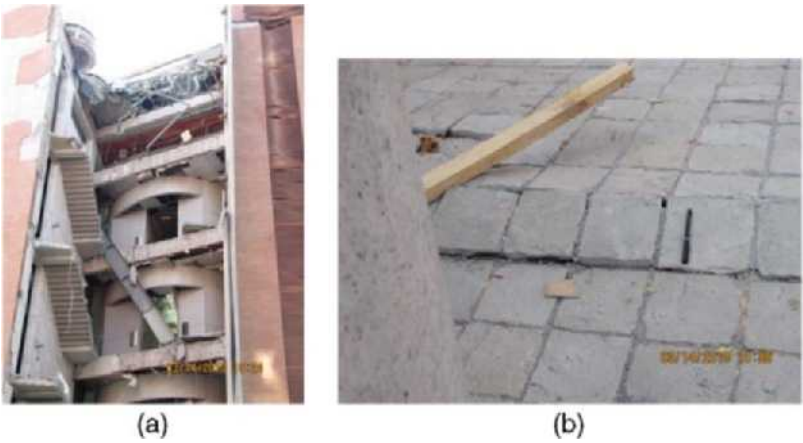
Figure 11. Six-story commercial building at 33.387985°S, 70.618815°W (1015 hrs on 03/14/2010). (a) Damage of emergency staircase. (b) Evidence of ground deformation.

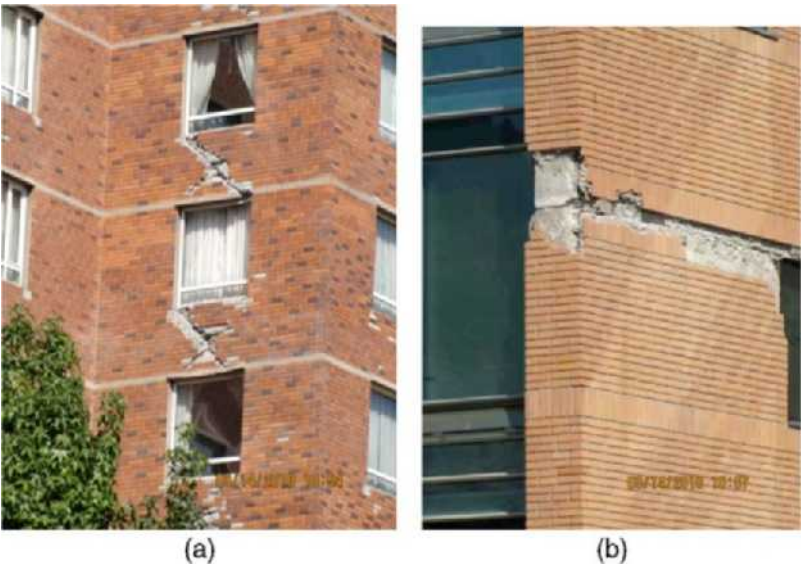
that site effects may have contributed to the concentrated structural damage at the site, while the strong structural damage variability at the site, with severely damaged structures adjacent to virtually undamaged ones has been partially attributed to the irregular structural configuration of the former.

Figure 12. (a) Twelve-story building with severe structural damage (33.387652°S, 70.617123°W, 1054 hrs on 03/14/2010); and (b) Five-story building with severe structural damage (33.389586°S, 70.618349°W, 1056 hrs on 03/14/2010).

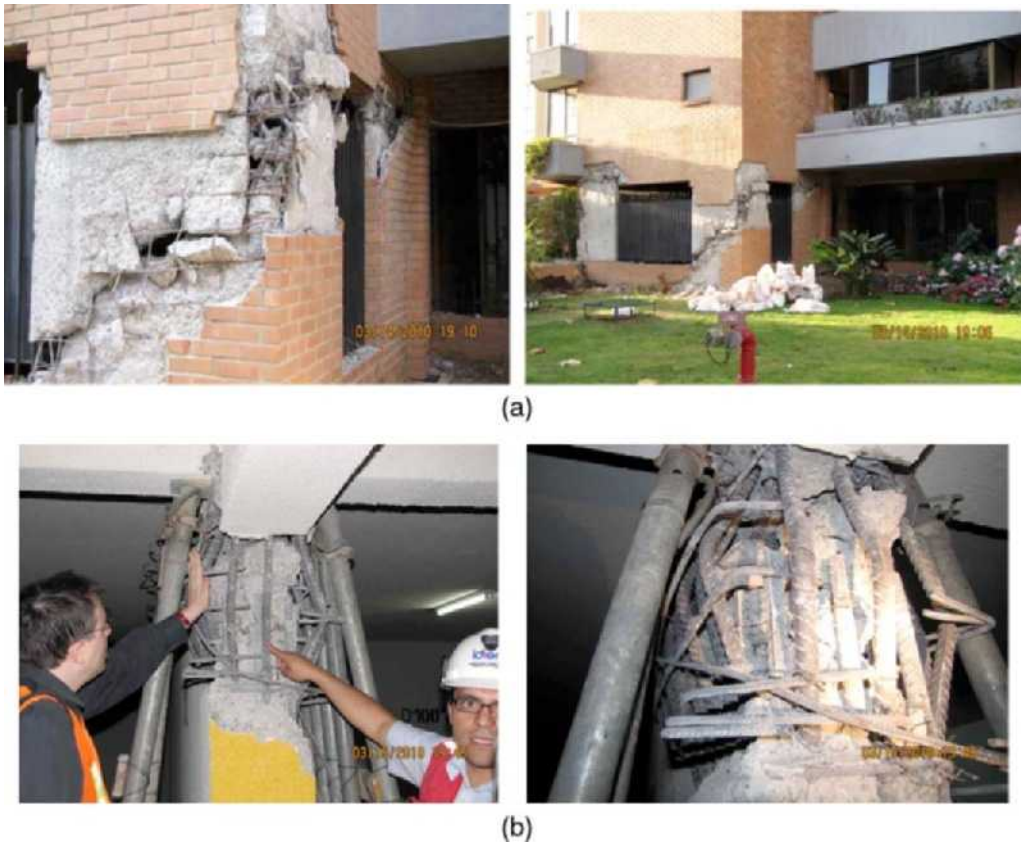
Indeed, the same damage pattern was observed during reconnaissance of the 2010 event. Five severely damaged buildings were inspected, all located in the vicinity of the Marga-Marga river mouth and thus founded on soft soil conditions. Note that during the microzonation study following the 1985 Earthquake, the Municipality of Viña del Mar mapped the location of buildings with 5 or more stories (Figure 15). The buildings inspected during reconnaissance after the 2010 Earthquake are shown on this map (also depicted on the aerial view of Google Earth), and are clearly located in the immediate vicinity of the river. Figure 16 depicts the structural damage observations of the reconnaissance team.

Figure 16. (a) Damaged 10-story building (33.016045°S, 71.551990°W, 1916 hrs on 03/14/2010) due to lack of confinement at the beam-column joints and low quality concrete; and (b) heavily damaged 20-story building due to lack of confinement at the beam-column joints (33.020074°S, 71.544055°W, 1945 hrs on 03/15/2010).

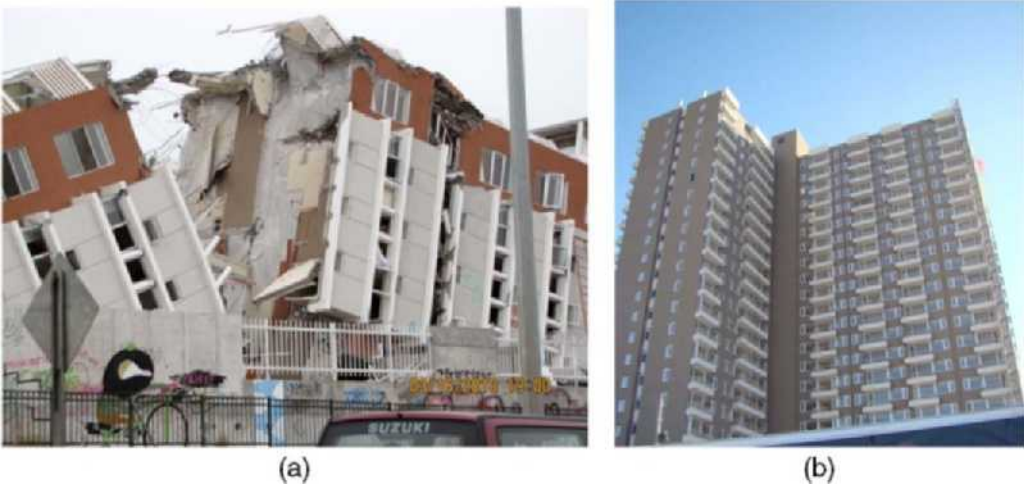
Figure 21. (a) Fifteen-story collapsed structure (36.828067°S, 73.061639°W, 1900 hrs on 03/16/2010) designed using Soil Type II conditions; and (b) 20-story structure adjacent to collapsed (36.828083°S, 73.060600°W, 1910 hrs on 03/16/2010) designed using Soil Type III conditions, and suffering only minor damages.

A striking example of the role of site conditions and soil-structure interaction in the seismic performance of structures is described below. Two adjacent multi-story structures were inspected during reconnaissance close to the Llacolén bridge in downtown Concepción (see location in Figure 19), one fully collapsed during the 2010 event and the other suffered minor damage and is currently being repaired. The 15-story collapsed building (Alto Rio) was designed using Site Type II (Chilean design code) on shallow foundation, and the one that did not collapse using Site Type III on pile foundations, which implies a higher design spectrum. While there is no evidence that the soil conditions are indeed different at the

locations of the two structures (distance between them of approximately 20 m), the difference in design spectra values may have played an important role in the failure of the building; according to the Chilean design code, the design spectral value for Type III soil conditions relative to Type II is 2.78 for period $T = 1$ s and 2.47 for period $T = 2$ s. The locations of the two buildings are depicted in Figure 20.
